Manhole Inspection Summary

Manhole # S31C__012MH

Insp Date: **8/7/08 3:06 PM**

Location Address: **425 saratoga st**

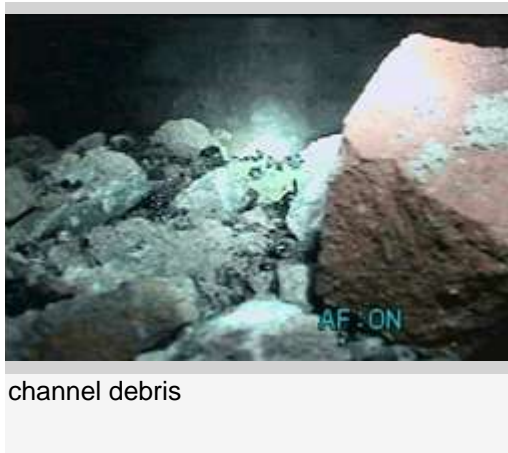
Defect 4

Condition: ☐ Sound ☐ Cracked ☐ Root Intrusion ☐ Deteriorated ☐ Leaks ☒ **Debris**

channel debris

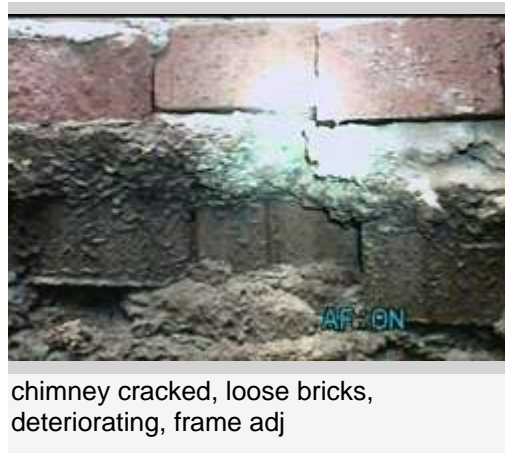
Defect 3

Chimney / Frame Adjustment ☒ Exists Material: **Brick and Concrete** ☐ Parged Height: **8** (in.)

Condition: ☐ Sound ☒ **Cracked** ☐ Root Intrusion ☒ **Loose Brick** ☐ Deteriorated

chimney cracked, loose bricks,
deteriorating, frame adj

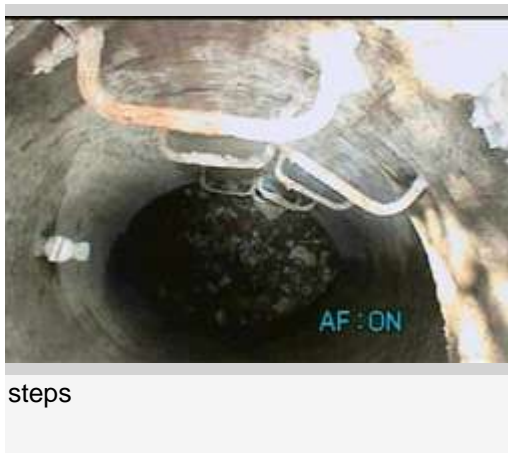
Defect 2

Steps Count: **8** Missing: **1** ☒ **Corroded**

steps

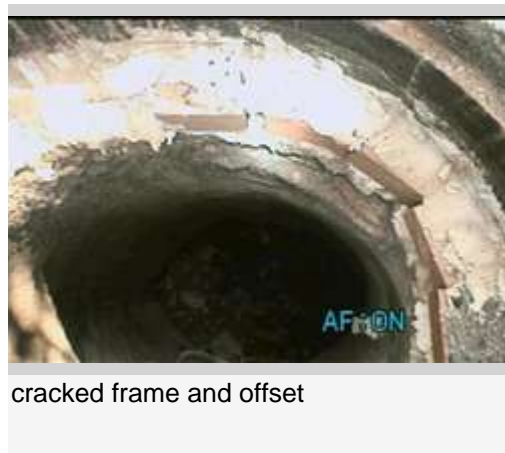
Defect 1

Frame Offset: **3.5** (in.) Condition: ☐ Sound ☒ **Cracked** ☐ Leaks

cracked frame and offset

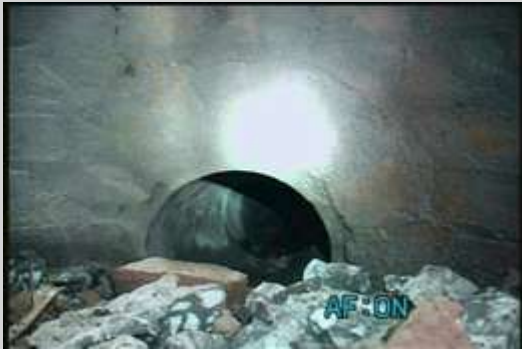
12 O'Clock Outflow

8 in. Circular Gravity Sewer
Pipe Out @ 12 O'Clock

Pipe Material: **Clay** ☐ Pipe Lined

Invert Depth: **12.00** (ft.) Flow Characteristics: **None**

Infiltration: **None** Pipe Seal Cond: **Unknown**

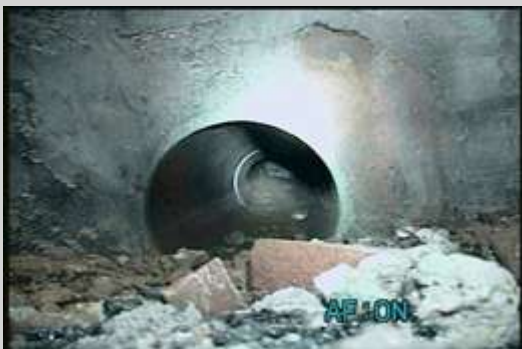
6 O'Clock Inflow

8 in. Circular Gravity Sewer
Pipe In @ 6 O'Clock

Pipe Material: **Clay** ☐ Pipe Lined

Invert Depth: **11.86** (ft.) Flow Characteristics: **None**

Infiltration: **None** Pipe Seal Cond: **Unknown**
